# Scientific Troubleshooting: Flash

Created exclusively for **Nexeo Plastics** by Routsis Training, this free guide contains excerpts from Routsis's *Scientific Molding Courses*.

# TROUBLESHOOTING FLASH

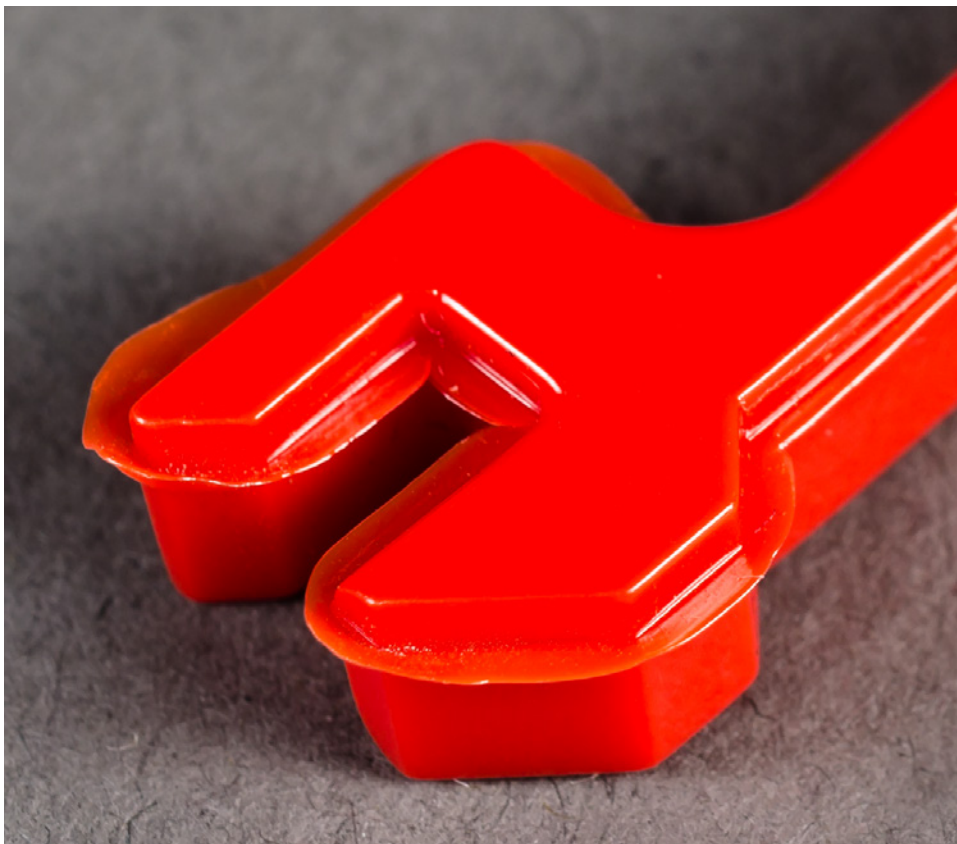
Flash is excessive, unwanted material located on the edges of a part. This is a result of material passing through the parting line or between mold components.

Flash can be caused by one of six major factors:

- Material Temperature
- 1st Stage Injection
- 2nd Stage Pressure
- Clamp Tonnage
- Mold Faults
- Machine Faults

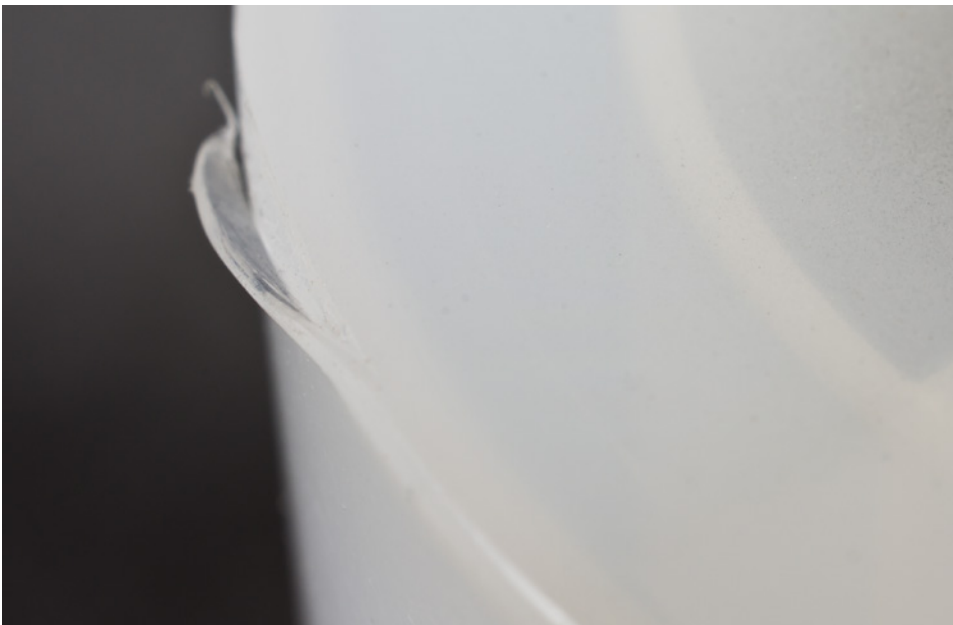
Much of the mold damage found in the industry is the result of carelessness. Any molder using hard tools, such as screwdrivers or pliers, to remove parts from the mold will usually cause damage.

Molds produced from aluminum and beryllium copper can even be scratched by softer tools made of brass.

A damaged mold may also cause flash to appear on molded parts. Dents and scratches, improper mold protect, poor mold handling, or excessive component wear are all potential culprits.
