Scientific Troubleshooting: Short Shots

TROUBLESHOOTING SHORT SHOTS

A short shot is an incompletely filled mold cavity and can be attributed to several different causes, including insufficient Melt Temperatures, Injection Velocity, and mold damage.

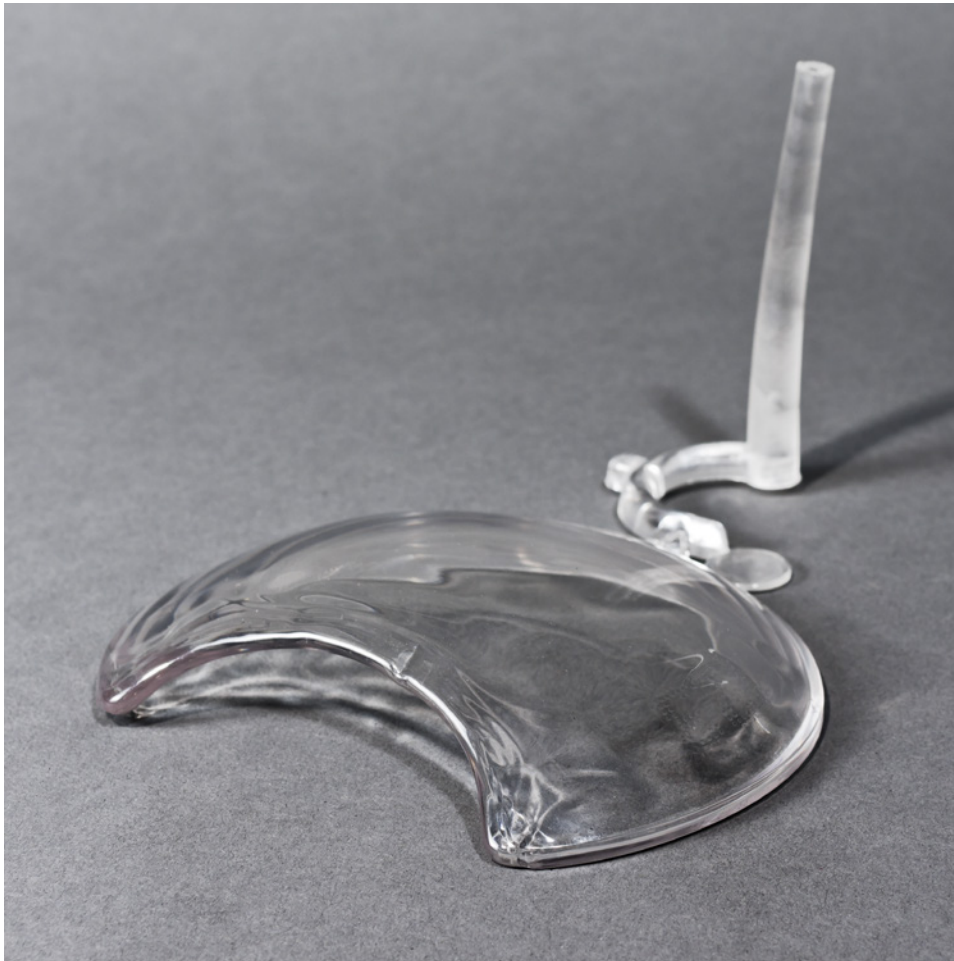
Short Shots can be caused by one of six major factors:

- Material Temperature
- 1st Stage Injection
- 2nd Stage Pressure
- Mold Temperature
- Clamp Tonnage
- Mold Damage

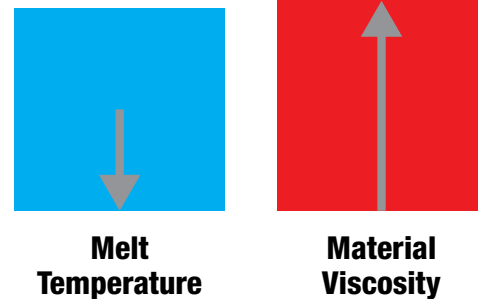
Material Temperature

A **Melt Temperature** that's too low may cause a short shot. If a low temperature, high viscosity, polymer is injected into the mold, the resistance to flow may prevent the mold from filling enough during 1st Stage Fill and result in a short shot.

To address a short shot produced from a low Melt Temperature, it is recommended to measure the Melt Temperature, and return it to the documented standard.

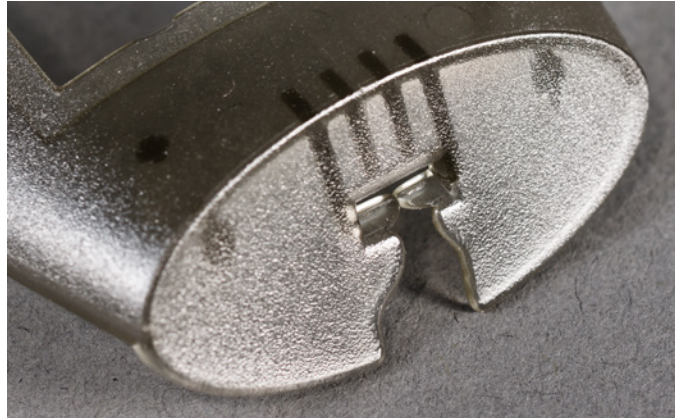
Short shots can result from insufficient Packing Pressure during 2nd Stage.

When the 2nd Stage Pressure is significantly low, there may not be enough pressure to complete mold filling when a short shot is used during 1st Stage Fill.

If 2nd Stage parameters are suspect, return the Packing Pressure to the documented standard.

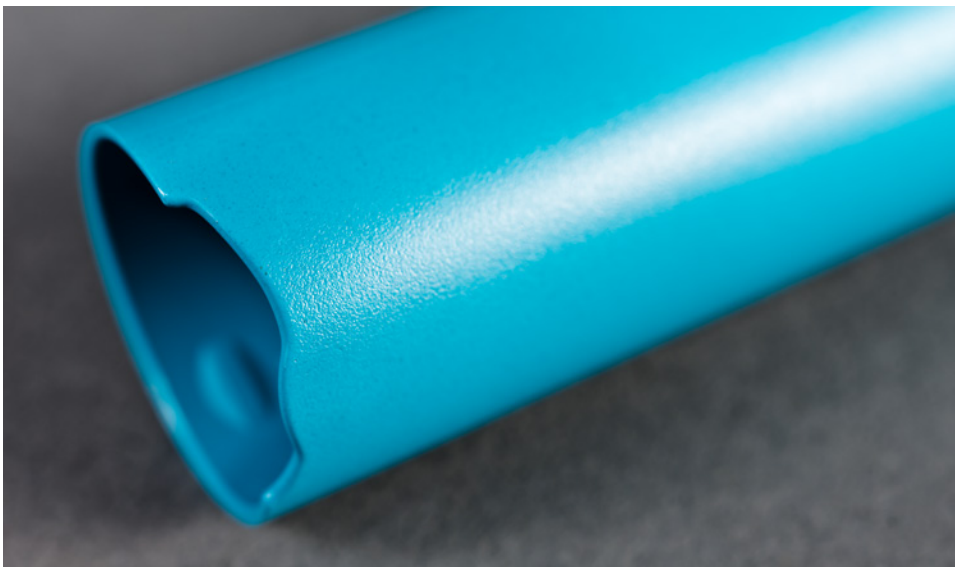
Short shots can result from a low Mold Temperature. If a significantly low Mold Temperature is used, excessive pressure drop may occur during 1st Stage Fill. This pressure loss may prevent the mold from filling — producing short shots.

When comparing Mold Temperature to the documented standard, the temperature of the water entering and exiting the mold should be measured and returned to standard. Also check the difference between the temperature of the water entering and exiting the mold. A low difference could indicate excessive coolant flow.

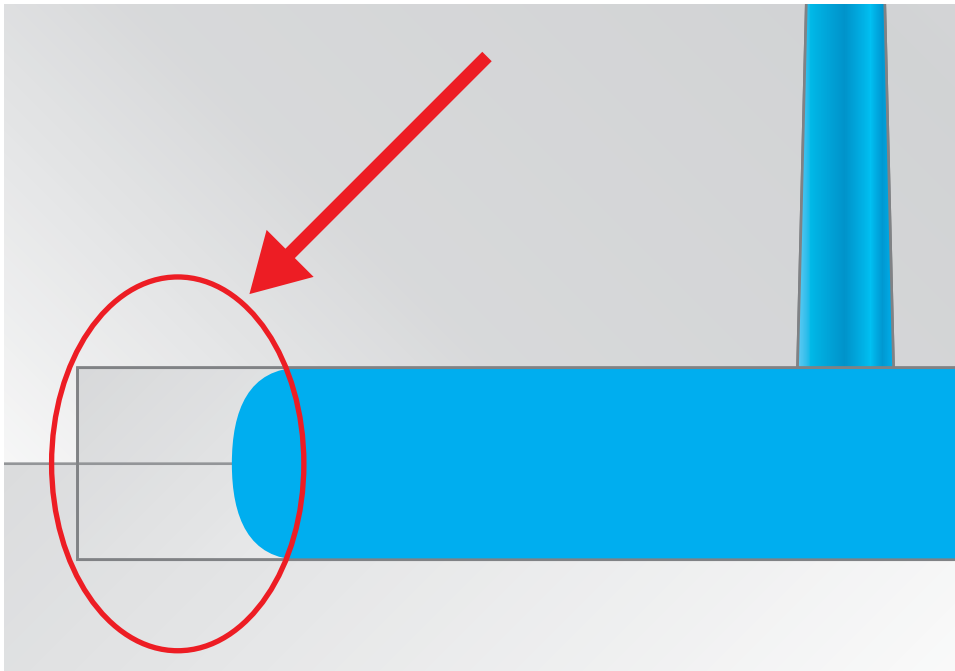
Short shots can also be the result of high Clamp Tonnage. Excessive Clamp Tonnage can compress the mold vents and prevent gas from exiting the mold during 1st Stage Fill. This trapped gas collects at the end of fill and prevents the polymer melt from filling the mold, thus resulting in a short shot.

Verify that the Clamp Tonnage setting matches the documented setpoint. You should also reset the Clamp Tonnage if a toggle clamp is being used.
